City of New Braunfels Standard Operating Procedures for Assessment of Dissolved Oxygen Conditions in Landa Lake & Operation of the Aeration System

August 31, 2015

Purpose: To evaluate dissolved oxygen (DO) concentrations in Landa Lake and operate the existing aeration system, as needed to mitigate low DO levels.

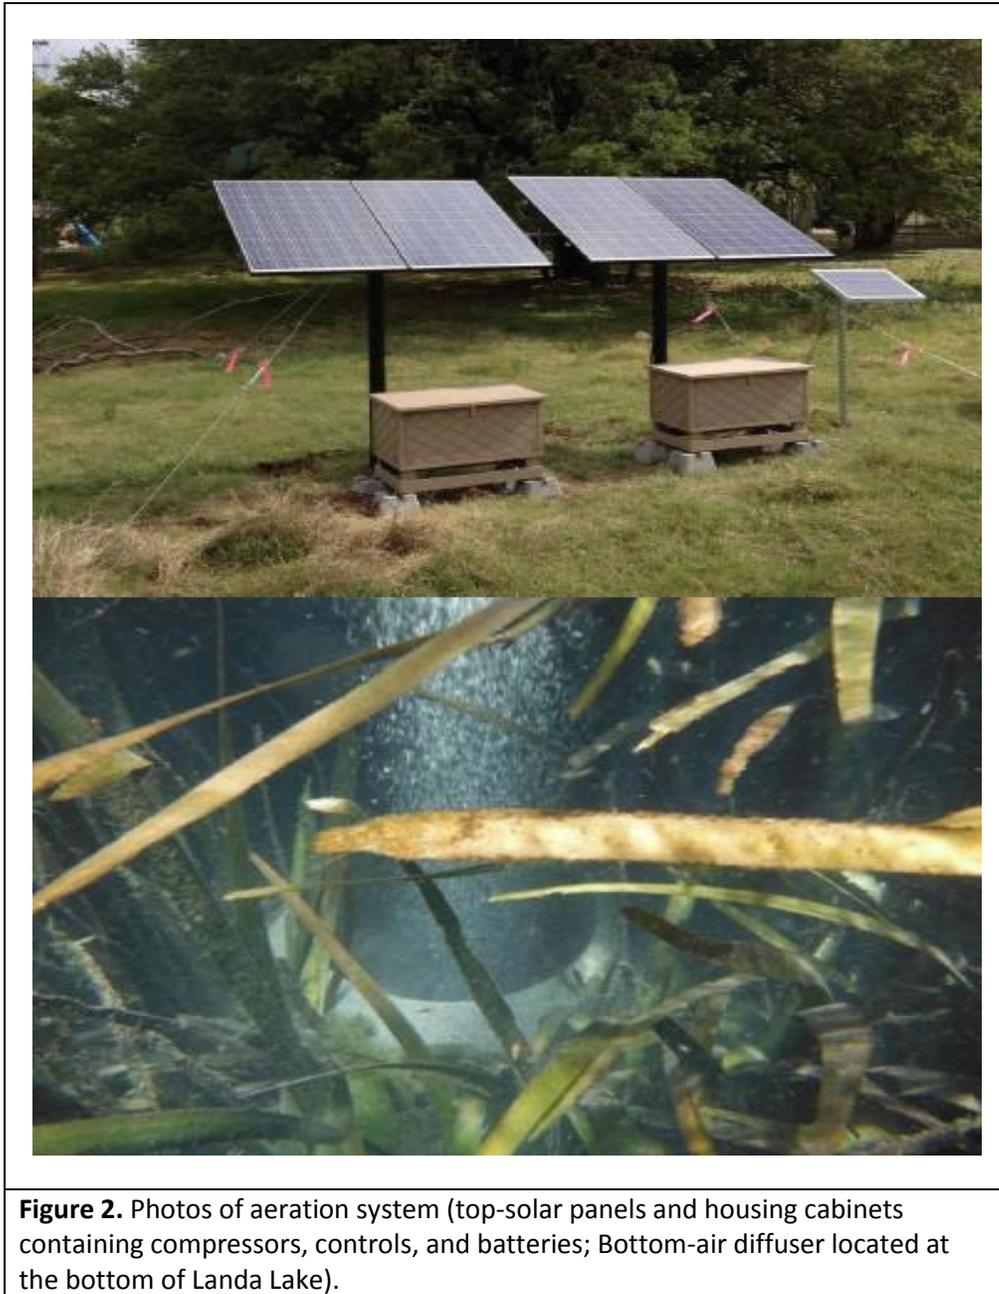
Figure 2. Photos of aeration system (top-solar panels and housing cabinets containing compressors, controls, and batteries; Bottom-air diffuser located at the bottom of Landa Lake).

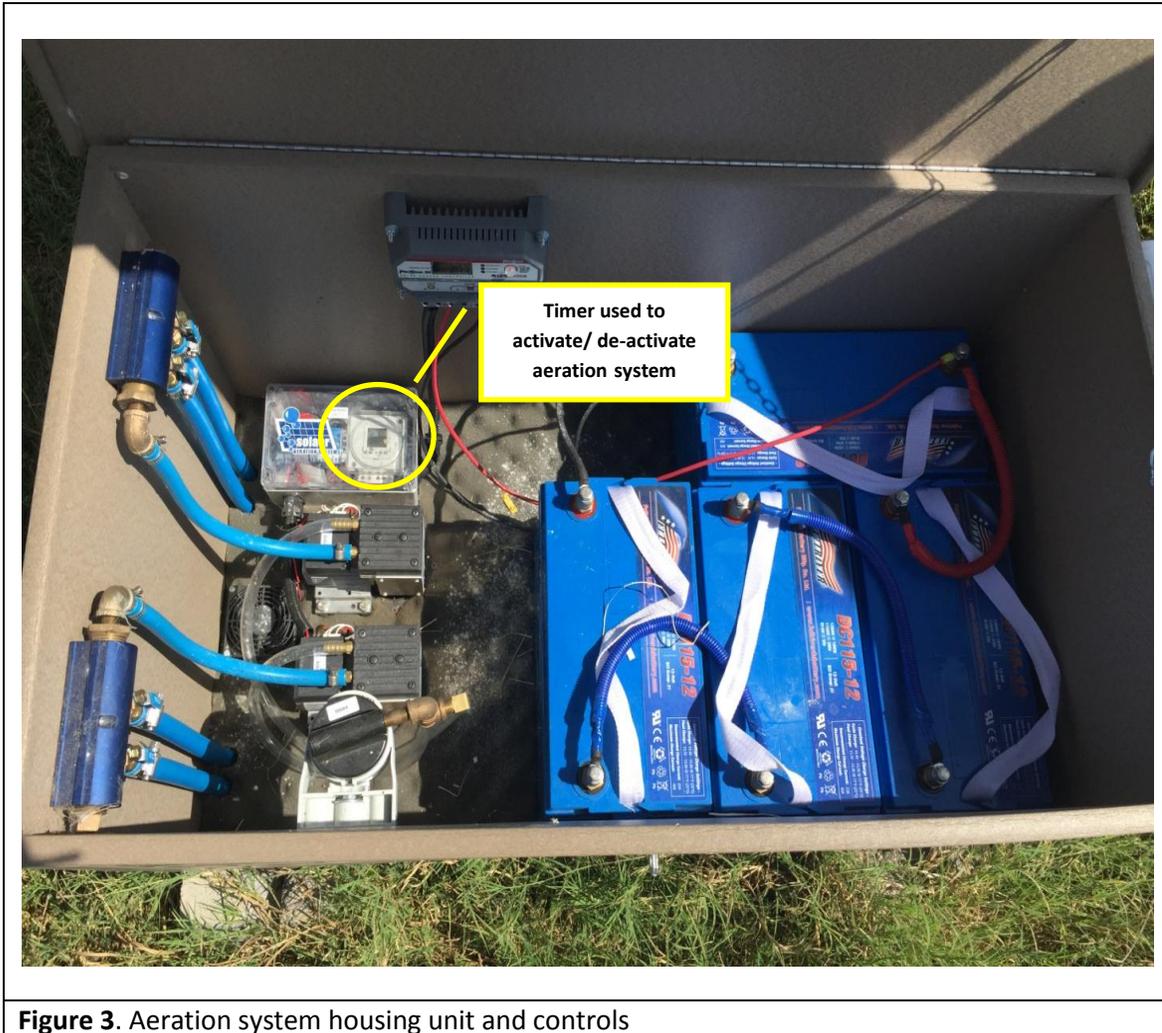
Figure 3. Aeration system housing unit and controls

3. The aeration system is manually activated by switching on the units at the control panel which is housed within the plastic housing cabinets (Figure 3). The plastic housing cabinets are equipped with a padlock to which CONB and SWCA staff retain keys.

4. The control panel includes a timer which can be set to activate/ de-activate the aerators at preset times. Although the timer can be set to activate the aerators only during periods of low DO (i.e., nighttime hours), the aerators are typically activated to remain operational continuously.

5. Each aerator line may be controlled independently by opening and closing valves on the aerator manifold. Each of the housing units contains similar configurations for controlling the system.
